**Fire Resistance Test Generally In  
Accordance With BS 476: Part 22: 1987,  
Clause 5, on an Uninsulated Fabric Barrier**

**Saveguard (UK) Limited**  
Tame Valley Mill  
Wainwright Street  
Dukinfield  
Cheshire  
SK16 5NB

**Report Issued** : 9<sup>th</sup> March 1999

**Date of Test** : 25<sup>th</sup> January 1999

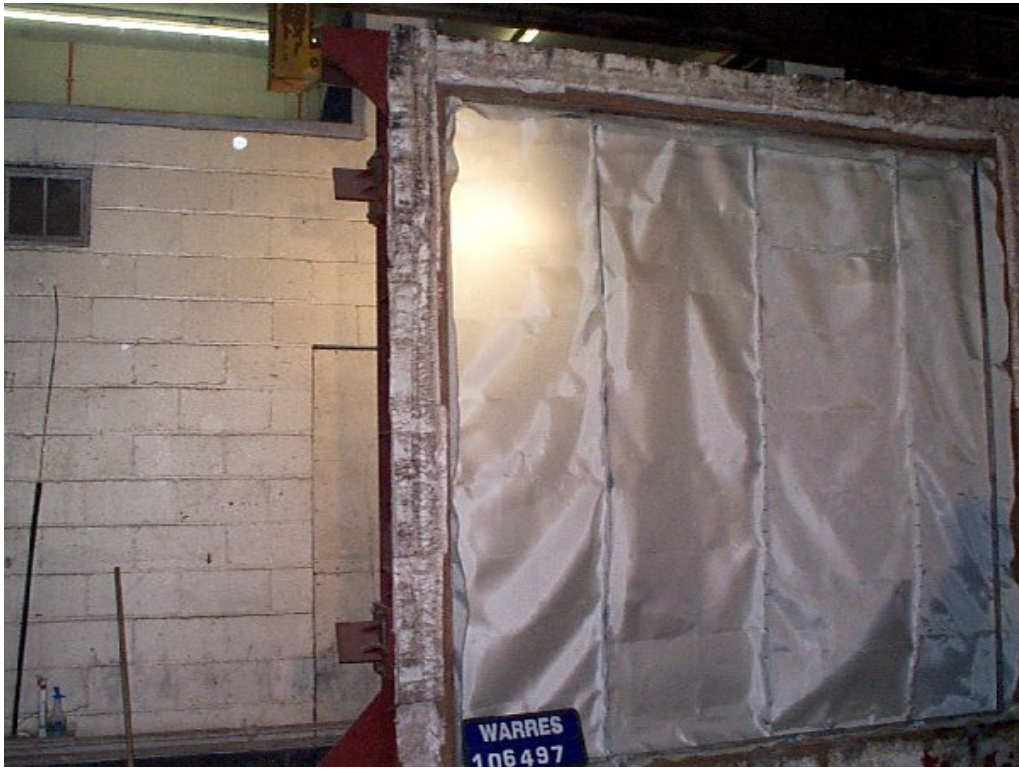
- Plate 1 - Unexposed surface of the specimen prior to testing.
- Plate 2 - Unexposed surface of the specimen during the test.
- Plate 3 - Unexposed surface of the specimen during the test.

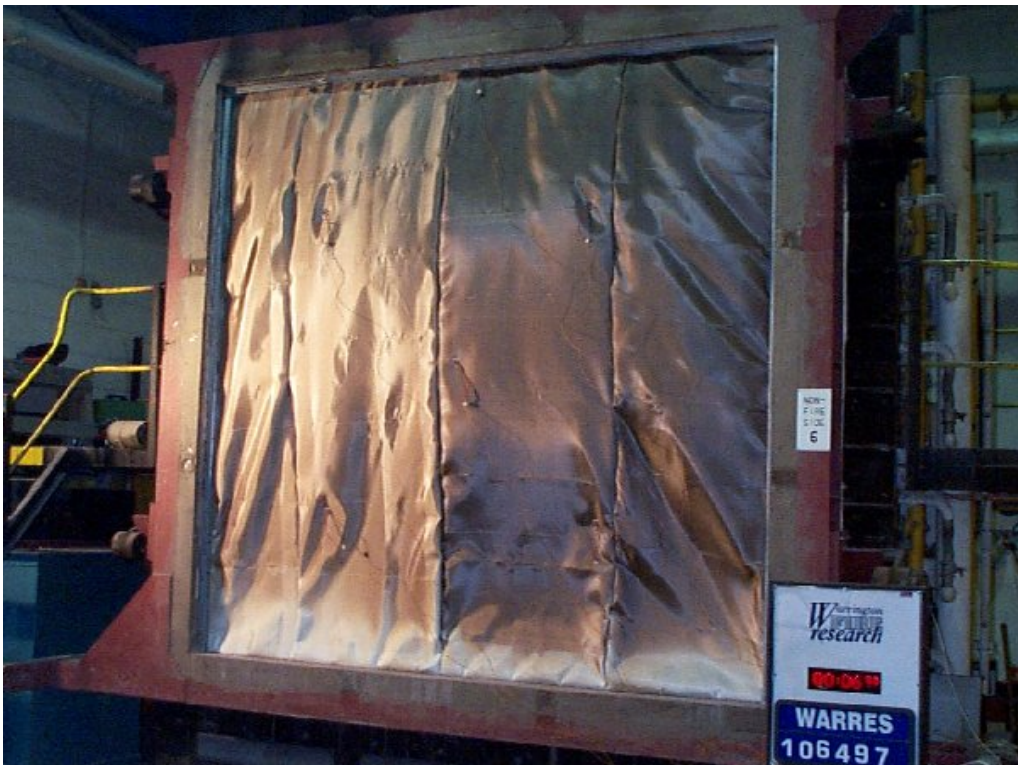
- Plate 4 - Unexposed surface of the specimen during the test.
- Plate 5 - Unexposed surface of the specimen during the test.
- Plate 6 - Unexposed surface of the specimen during the test.

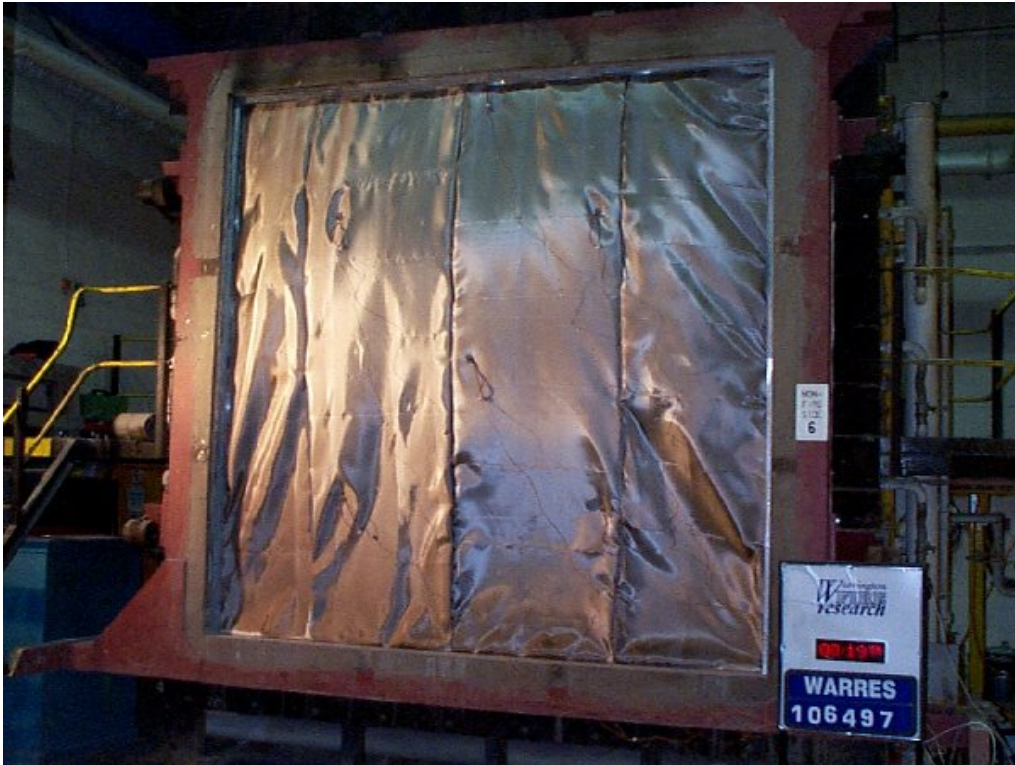
- Plate 7 - Unexposed surface of the specimen during the test.
- Plate 8 - Unexposed surface of the specimen during the test.
- Plate 9 - Unexposed surface of the specimen during the test.

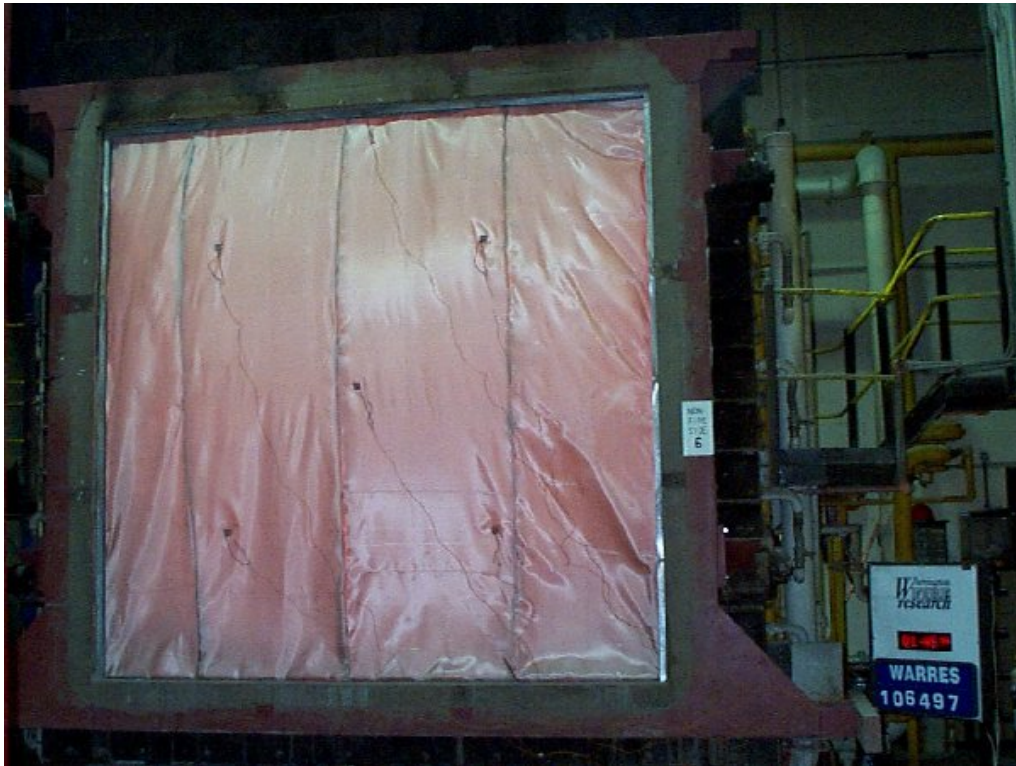
- Plate 13 - Unexposed surface of the specimen during the test.
- Plate 14 - Unexposed surface of the specimen during the test.
- Plate 15 - Unexposed surface of the specimen during the test.

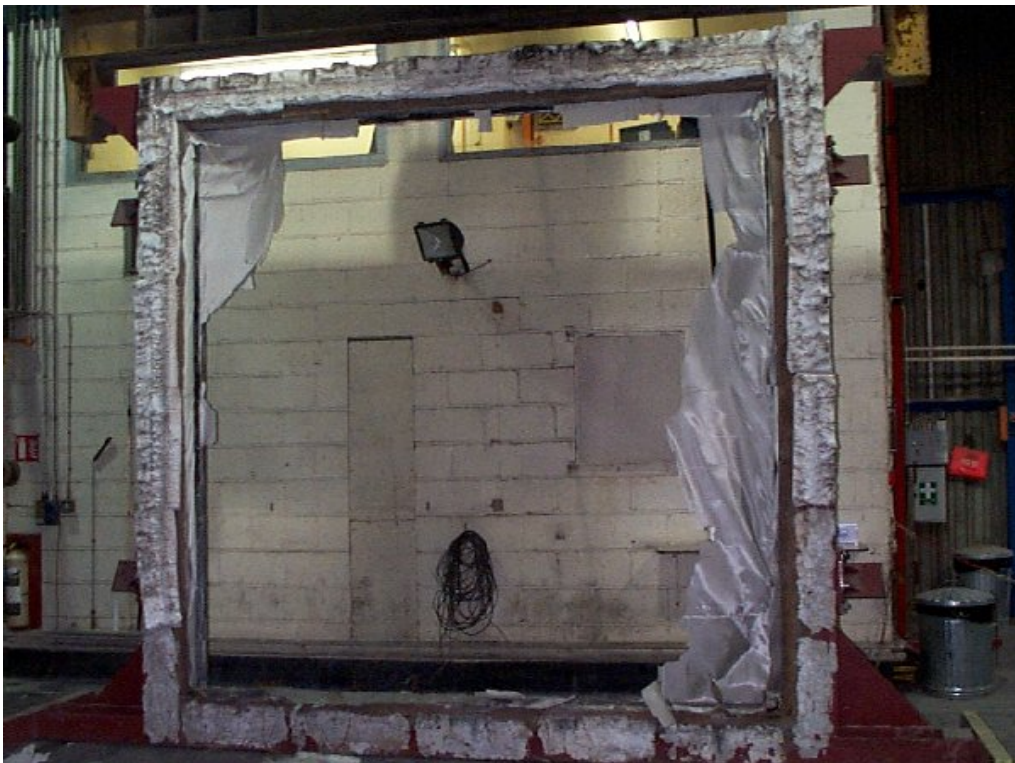
- Plate 16 - Exposed surface of the specimen after the test.
